## ALASKA VEHICLE TEST \ FINAL REPORT

**This report has been prepared for the ZERO SOUTH team and includes information required by the State of Alaska, Department of Natural Resources, in response to LAS-30762 Stipulation 25, submission of a completion report**

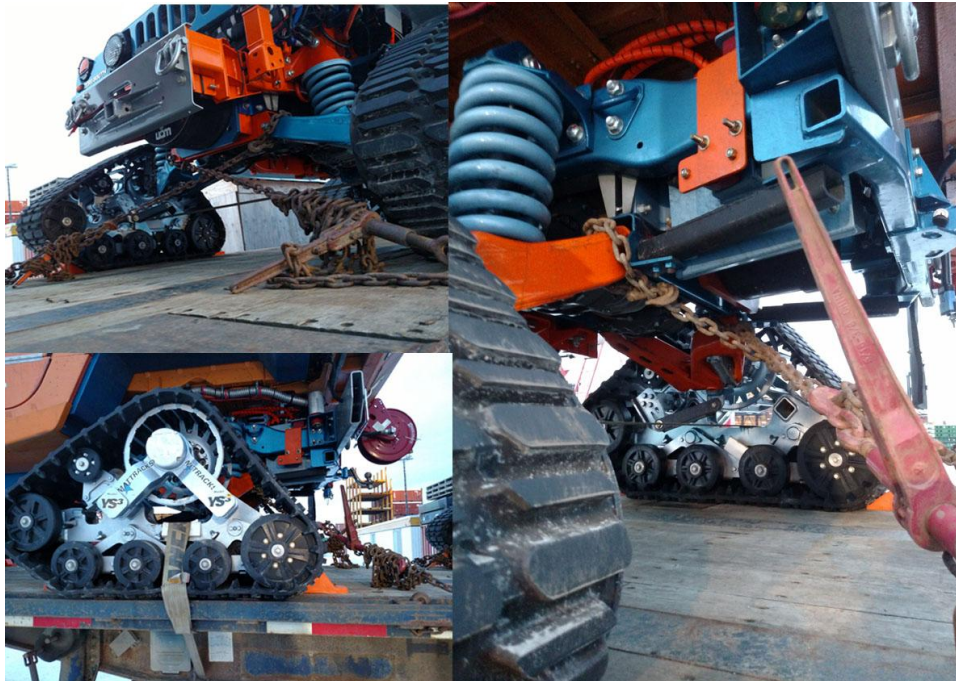
Eight transfer and lashing phases took place during the expedition, where observation resulted in several important lessons learned. During the northbound road segment to Tacoma, PTV1 nearly fell off the truck because it was lashed improperly with straps. The truck hit a large bump causing the front end of the vehicle to lift and come down (fortunately in the same position) with tracks turned 40 degrees. The driver stopped to secure the load but, for this reason, all future transfer and lashing operations must be strictly overseen by a qualified rigger with these requirements: 1. use chain and chain binders as the primary means of lashing the vehicle. 2. chains must go around all four lower control arms. 3. individual straps must go through each track and these straps should be fastened to the trailer's adjustable side latches. 4. wood or plastic wedge pieces should be nailed to the deck in front of and behind each track. 5. additional fore and aft straps are a good idea in case a chain breaks.

*Observations made during three of eight vehicle transfers resulted in new methods for securing the ZERO SOUTH PTVs for transport. (Photos by Nick Baggarly)*

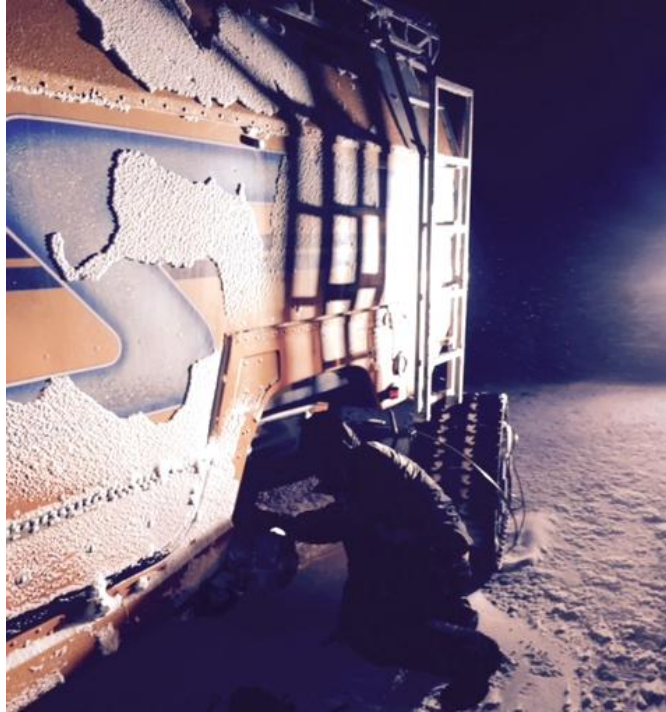
At 20:00 hours on February 7, approximately 40 miles into the sea ice drive, PTV2 sheared all of the studs on the left-rear spindle and dislodged its track. After examining the problem, Charlie Zacarias announced the vehicle could be repaired by taking one or two studs from each corner on both vehicles and this was done with all team members participating in the repair to some degree. Realizing this would fix the symptom and not the cause of the drive-line problem (which could become worse), the team decided to return to Oliktok Point. On the way back, approximately 10 miles east of this position, PTV2 suffered an unmendable immobilization when the same corner sheared its spindle causing the track to come off. Fortunately, it was held in place by its limit arm and remained with the vehicle and no damage to the wheel arch or fuel tank occurred. The location of the breakdown was in Harrison Bay just past the Colville delta at GPS position, North 70°, 32.970 minutes by West 151°, 47.286 minutes and a team photo was taken at this location. With the majority of the expedition test plan completed, and no repair parts on hand, the team decided to conclude the activity on the ice and leave the vehicle and return later to recover it. For future field operations, the team should devise a way of towing a vehicle with a broken corner.

After the left-side hub was replaced, and track installed, the right-rear track was removed and the spindle clamp nut was checked for excessive end float. It had none so the track was re-installed. Zacarias suggested changing the recovery plan and driving the vehicle back to Prudhoe Bay on tracks which was agreed. Approximately 40 miles later, PTV2 successfully reached OOGURUK Island and the two said farewell to guides, Arey, Tukle and Nukapigak. They retrieved the support vehicle and departed the island along the four-mile ice road. During this stretch, the solid ice surface was very slippery and the rear of PTV2 was now very noticeably pulling to the left. Although the left-rear hub had been replaced, a rear-end binding issue was still occurring and very-much noticeable. This suggests that the hub failure

was likely caused by binding somewhere else in the driveline--an axle, differential or brake issue perhaps. The vehicle traveled at 35 MPH for approximately ten miles on the Prudhoe road system and then PTV2's right-rear spindle broke. Fortunately, they came equipped with a replacement and it was repaired on the side of the road. Having broken both rear hubs within 50-miles of each other, a rear differential, axle or brake binding theory was now a genuine concern so rather than continue on, they decided to drive PTV2 to the nearest inhabited pad, which was the ConocoPhillips tool shed, and leave it. Later that morning, Carlile retrieved PTV2 and brought it back to Deadhorse. An examination of this issue is critical to the success of future missions. A list of possible causes or contributors are in the failure analysis table below.

PTV2 GEARED HUB FAILURE POSSIBLE CAUSES AND CONTRIBUTORS	PROBABILITY
rear end alignment was noticeably out	HIGH
gears and spindle inside geared hub were worn, weak or abused from previous owner	UNKNOWN. Disassemble and inspect damaged hubs
loose or weak clamp nut	UNKNOWN
tow bar induced side loading into vehicle (and tracks)	UNKNOWN
differential problem (binding)	HIGH (PTV2 rear end was noticeably pulling to the left during the 953-mile drive through Alaska which would suggest a binding problem in the rear. The possibility that the brake modulation (locking) feature of the HMMWV differential is incompatible with the electric motor and brake system combination. This should be investigated.
axle problem (binding)	HIGH (PTV2 rear end was noticeably pulling to the left during the 953-mile drive through Alaska which would suggest a binding problem in the rear
brake or emergency brake problem	HIGH, PTV2 rear end was noticeably pulling to the left during the 953-mile drive through Alaska which would suggest a binding problem in the rear. PTV2's emergency brake cable was adjusted frequently during the drive north and may be the cause of binding.

the tow bar exerts considerable tongue weight	UNKNOWN, tow bar design seems problematic
spindle weakening occurred due to high side loads placed into rear tracks by the sled's tow bar during tight turns or u-turns on snow	UNKNOWN, PTV2 made between two and 4 u-turns while sled was attached, tow bar design seems problematic. NOTE: if side loading is found to be the cause we MUST add a warning to vehicle training guide and <i>Driver</i> role definition.
PTV2 was overloaded	PTV2s roof rack carried approximately 25 gallons of fuel and a set of four tires. In hindsight the tires should have been placed on PTV1's roof rack or placed beneath the SnowStream on the sled
on acceleration, the tow bar's slip joint bottoms out and sends a shock "thud" (a sudden load) into the rear end of the tow vehicle	UNKNOWN, tow bar design seems problematic

***Braving -20° Fahrenheit and 20 MPH winds, Charlie Zacarias replaces a geared hub on PTV2. Component-level repair is necessary rather than attempting a rebuild in-the-field. (Photo by Nick Baggarly)***

- Replace all wheel studs with new (N. Baggarly)
- Spindle studs, geared hub rebuild parts and full replacements on spares and parts to order lists (N. Baggarly)

- The team should devise a way of towing a vehicle with a broken corner. A 2 foot square piece of railroad tie strapped beneath the lower control arm of the chassis, resting on a recover ski would do it.
