## ALASKA VEHICLE TEST \ FINAL REPORT

**This report has been prepared for the ZERO SOUTH team and includes information required by the State of Alaska, Department of Natural Resources, in response to LAS-30762 Stipulation 25, submission of a completion report**

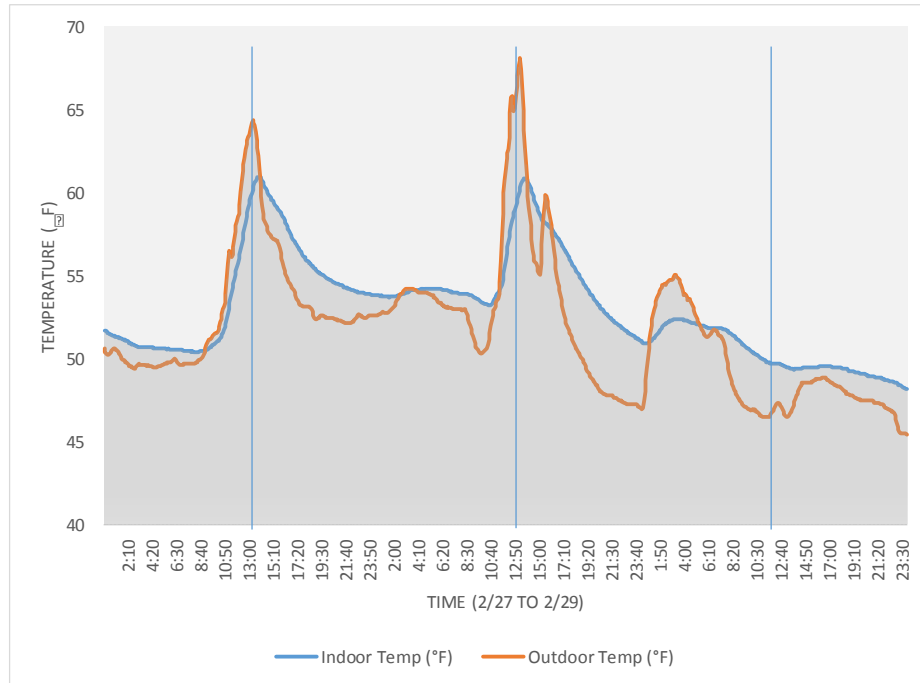
Figure 2: Area A Magnified

Two areas of interest were magnified to better understand the thermal performance of the Snowstream. Area A (Figure 1) reflects a typical non-operational status of the Snowstream. The indoor temperature swings are generally more moderate than outdoor temperatures. Indoor temperature during peak outdoor temperature remained 2-6°F cooler and 1-3°F warmer in the evening and early

morning hours. These findings are to be expected and may be slightly skewed due to convective forces experienced during transport.

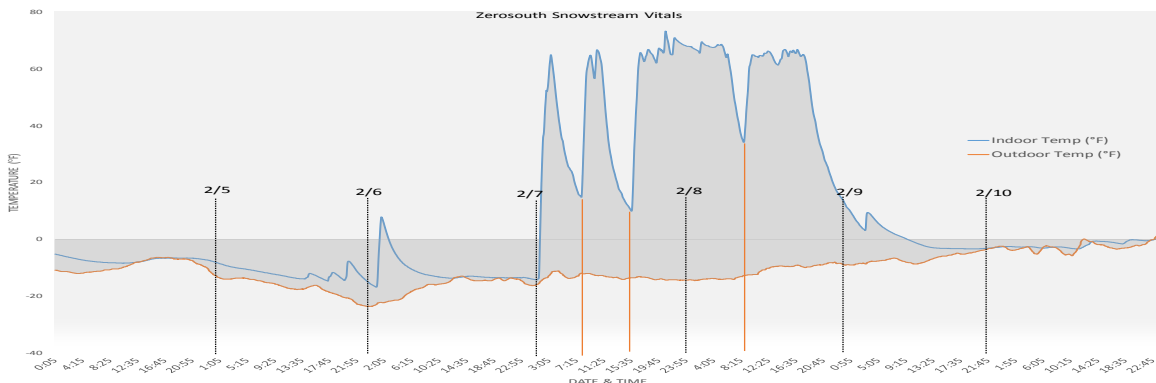
Figure 3: Indoor & Outdoor Temperature Enlarged

Area B in Figure 1 is magnified and illustrated in Figure 3. Area B captures February 5 through the 10 where it appears that an internal heat source was applied to the Snowstream. Based on the readings there was an anomaly around 01:25 (00:25 UTC-8) raising the temperature from  $-16^{\circ}\text{F}$  to  $7^{\circ}\text{F}$  and then declining to sub-zero ( $^{\circ}\text{F}$ ) temperatures shortly thereafter. On February 7<sup>th</sup> it appears that a heat source was turned on at 01:45 (00:45 UTC-8) with a starting indoor temperature of  $-10^{\circ}\text{F}$  and climbed to a maximum temperature of  $64^{\circ}\text{F}$  in less than 2 hours. Indoor temperatures then dropped to  $14^{\circ}\text{F}$  at 08:00 (07:00 UTC-8) when the heat source was reapplied, bringing the indoor temperature to a maximum of  $66^{\circ}\text{F}$  within 2 hours. This trend appears twice on the 7<sup>th</sup> until the evening when indoor temperatures average approximately  $67^{\circ}\text{F}$  until March 8 at 05:20 (04:20 UTC-8) when heat source was turned off or set to a lower temperature.

Based on this effort, the Antarctica expedition should deploy a more robust set of data loggers to capture broader more informative measurements including, kBTU, CO2, carbon monoxide, and track the operations of doors and vents and human behavior.
